X-Ray Non-Destructive Testing

Example Application: Inspection of High Voltage Cables

Application Note

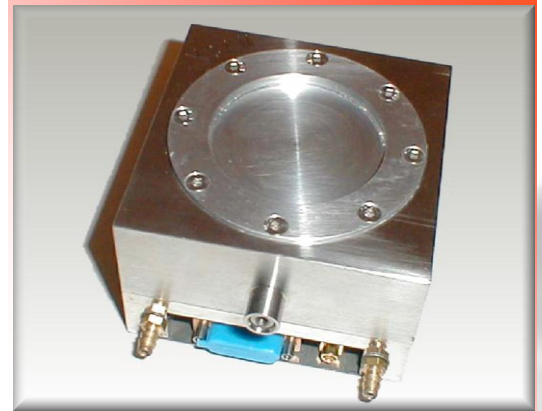
Figure 1 The CCD camera head housing a CCD bonded to a scintillating fibre optic plate (SFO), supplied by Xcam Ltd.

- The work carried out by the University of Southampton has used an X-Tex microfocus X-ray source to generate X-rays and an X-ray CCD camera supplied by Xcam Ltd and shown in Figure 1. The CCD has 2048×2048 $13 \mu\text{m}$ pixels and is connected to a scintillating fibre optic plate with a 1:1 ratio providing a 27.6×27.6 mm field of view, and X-ray efficiency up to 200 keV. The CCD made it possible to produce digital images of small sections of the cable down to feature sizes of $20 \mu\text{m}$, with relatively low noise.

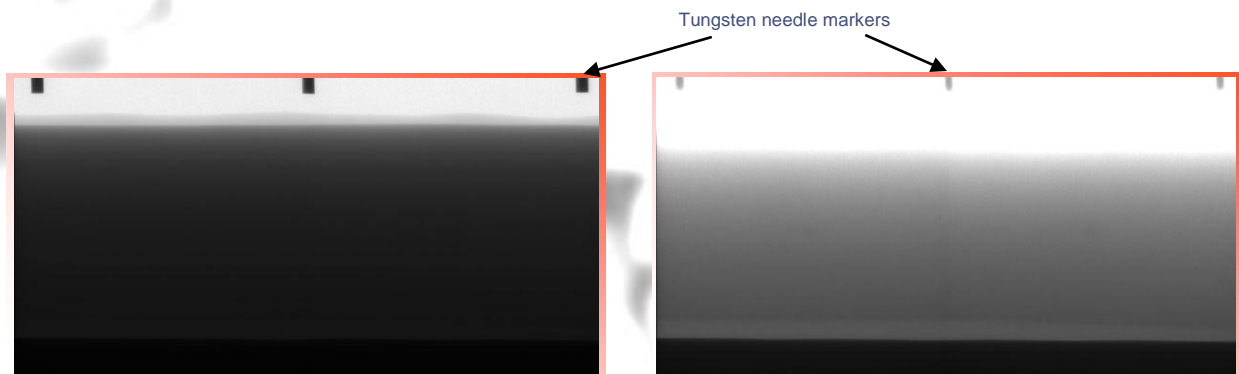
Figure 2 Two montaged CCD images of the studied cable joint using a different contrast setting in each case to highlight the various layers in the cable

- The joint used for inspection was a section of 90 kV submarine cable. A CCD image of the joint was accumulated during 90 second X-ray exposures, the median pixel intensity of 10 such images being used to obtain the final image for analysis.

- The small CCD field of view required the cable joint to be imaged in 27 mm sections along its length. Tungsten needle markers were positioned just above the surface of the cable in regular intervals to allow mounting of several images. Figure 2 shows a final montaged image of the cable joint.

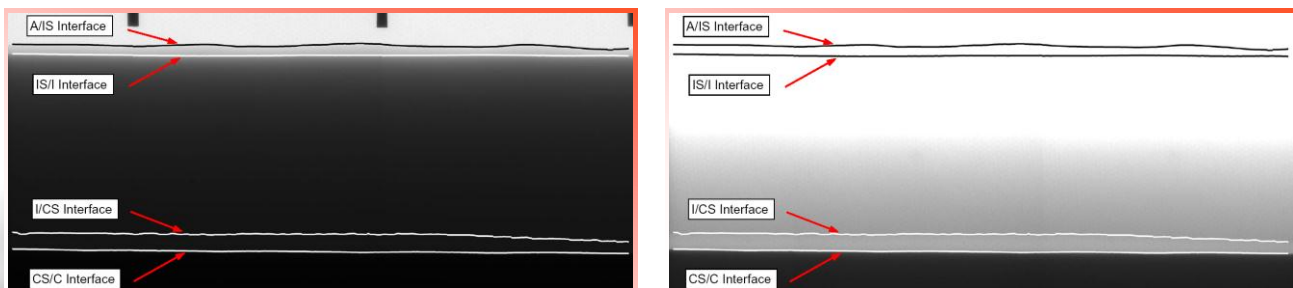
Figure 3 Two montaged CCD images, using different contrast settings, of the studied cable joint combined with the binary interface image. The different layers in the cable are labelled for clarity

- Taking vertical sections through the cable joint image reveals the change in measured pixel intensity through the different layers in the cable. Differentiating these intensity profiles for each column in the image allows the position of the various interfaces to be found: air/outer semiconducting sheath (A/IS), outer semiconducting sheath/insulation (IS/I), insulation/inner semiconducting sheath (I/CS), inner semiconducting sheath/conductor (CS/C). The minimum, maximum and average thickness of each layer can then be calculated, providing a qualitative assessment of the cable joint.

- Every interface point is then stored in a binary image of the cable joint which can be superimposed onto the original image of the cable joint to clearly show the interface lines. Figure 3 shows a montaged CCD image of the cable joint, combined with the binary interface image. All four interfaces were found and are labelled in the figure.
